REFERENCE: Heirloom Joinery
467 Takou Bay Road
RD2
Kerikeri

Performance tests on double glazed Timber framed large fixed light window with tilt and turn inward opening door in accordance with NZS 4211:2008 Specification for Performance of Windows

DATE OF TEST : 12 & 18 November 2013

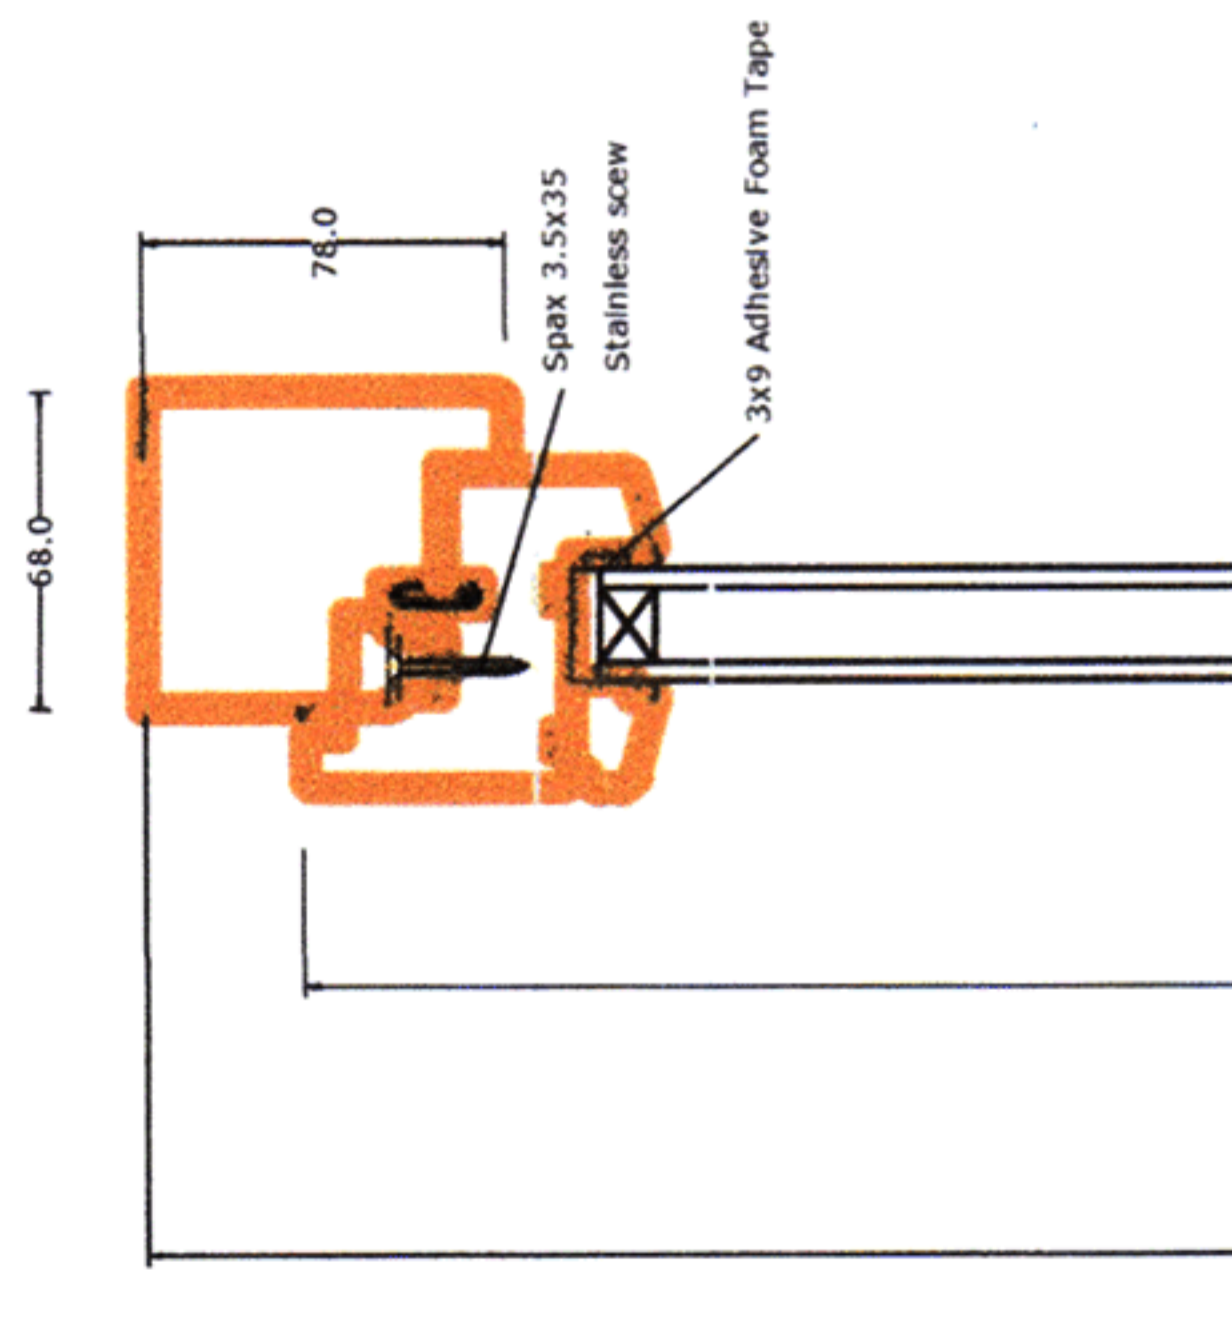
Vertical Section - Active Sash

During an initial water penetration test, water penetration occurred at several positions below the inward opening door seal. The client determined that the locating slot for the bottom seal had been incorrectly positioned, and removed the door panel for modifications to correct the seal alignment.

Following the modifications by the client to correctly reposition the bottom rail closing seal on the door panel, the double glazed Timber framed large fixed light window with tilt and turn inward opening door complied with the
